Lawrence Livermore National Laboratory
Experimental Test Site 300

Compliance Monitoring Program for the
Closed Building 829 Facility

Annual Report
2012

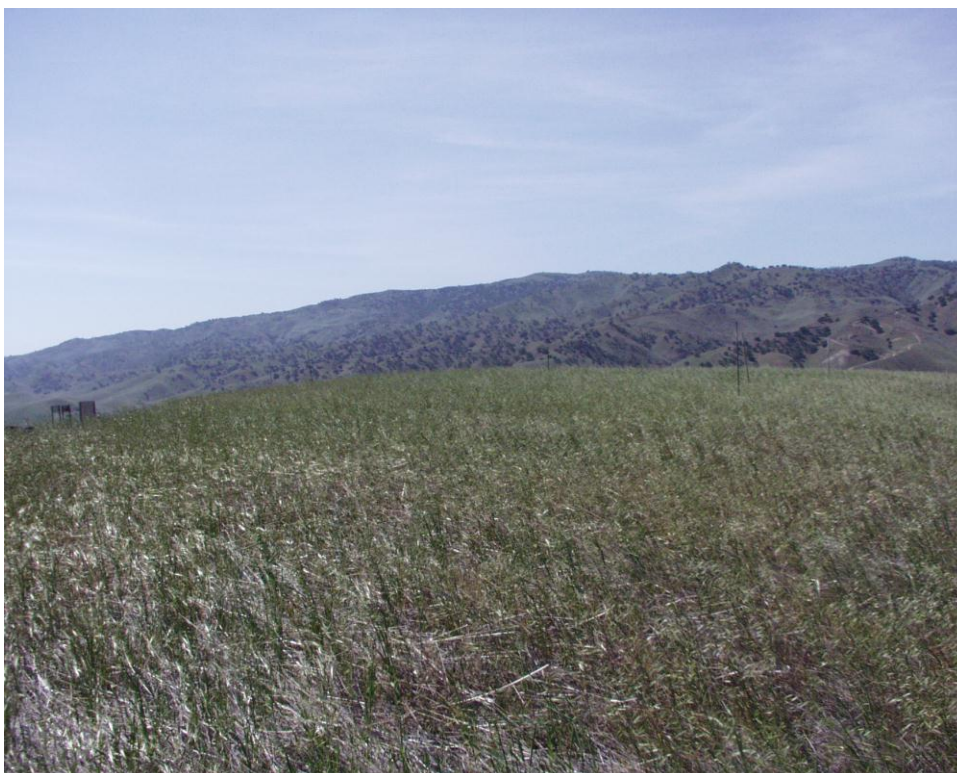
Figure 4 Building 829 Landfill Vegetation Cover Condition

Building 829 Landfill cap is in good condition. The vegetation cover is thick and covers the soil cap over the pits; there is no visible erosion of the cap; and the drainage system is in good condition and appears to be functioning as intended. The groundwater monitoring system appears to be in good condition as well. Vegetative debris accumulation was observed in the drainage ditch. Recommendations on these observations are made in section 2-14.

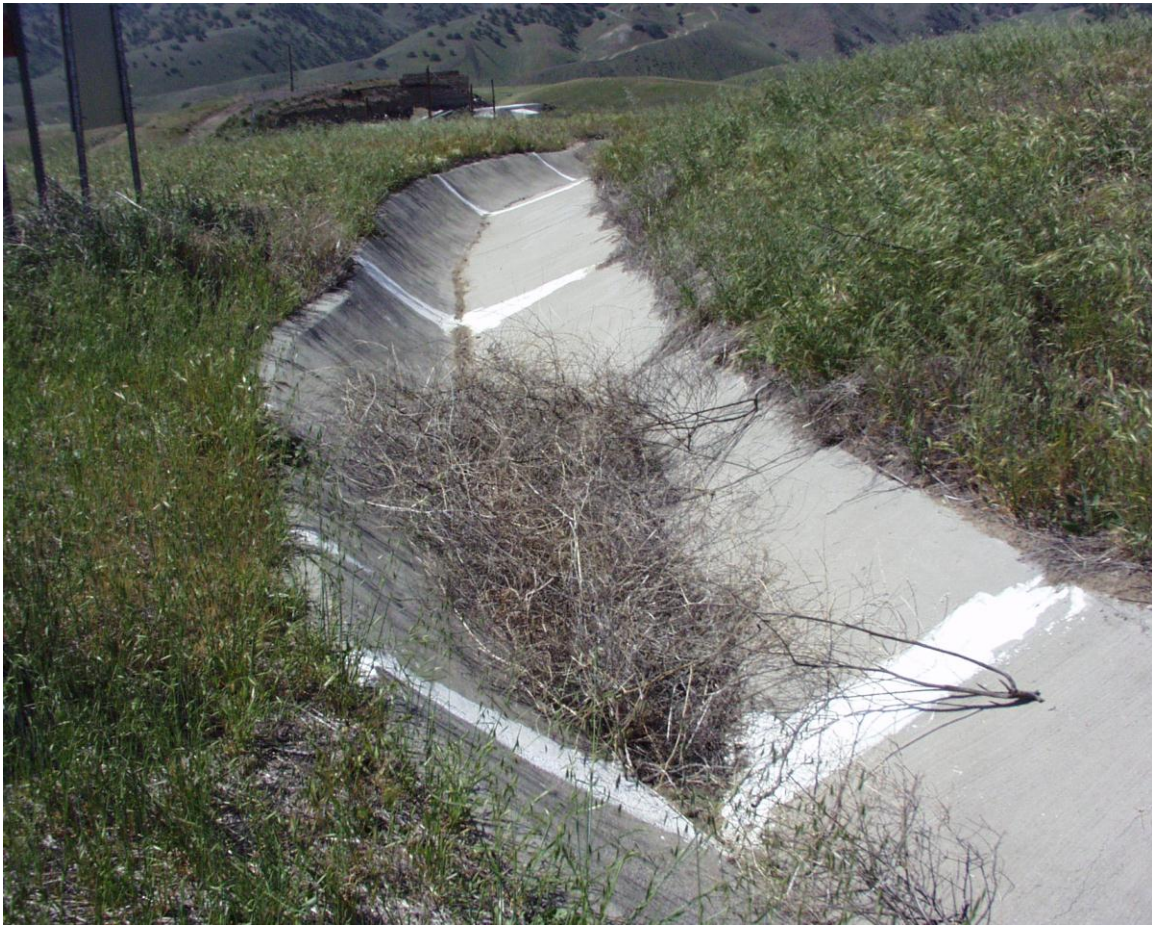
Figure 5 Building 829 Landfill Vegetative Debris Accumulation in Concrete Drainage Ditch

Surface runoff diversion structures consist of a perimeter drainage V-ditch. The V-ditch has expansion joints every 12 ft and every other one is caulked. The remaining expansion joints appear to be saw cuts partially onto the surface of the concrete. The structure also collects water from the “drainage layer” of the cap through a series of drainage pipes. Concrete lining appears to be in good condition. Evidence of vegetation debris accumulation in the drainage ditch was observed, see Figure 5. It is recommended that vegetative debris be cleaned out.

- Remove vegetative debris from the concrete lined drainage ditch.
